## **TECHNICAL INFORMATION LETTER**

### **LUBE OIL VARNISHING**

This TIL applies to all heavy-duty gas turbines.

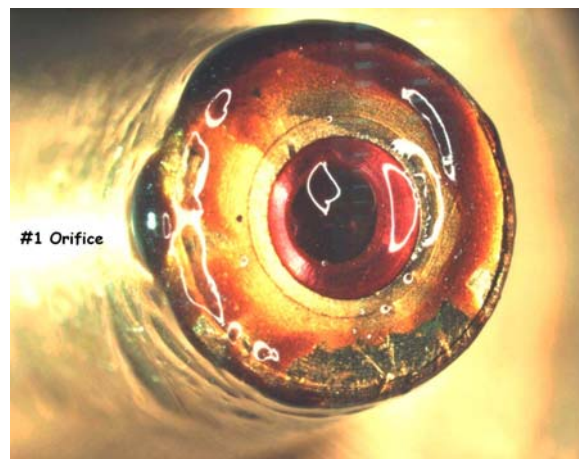
**Figure 1: Varnish on Servo Orifice**

While the issue of oil varnishing typically does not lead to extended forced outages, the availability and reliability of the units can be greatly affected. The varnish tends to accumulate in small, low flow passages within the hydraulic system – typically in servo valves associated with hydraulically operated components. Once the varnish is established, the servo valves become sluggish or fail to operate, leading to a trip of the unit.

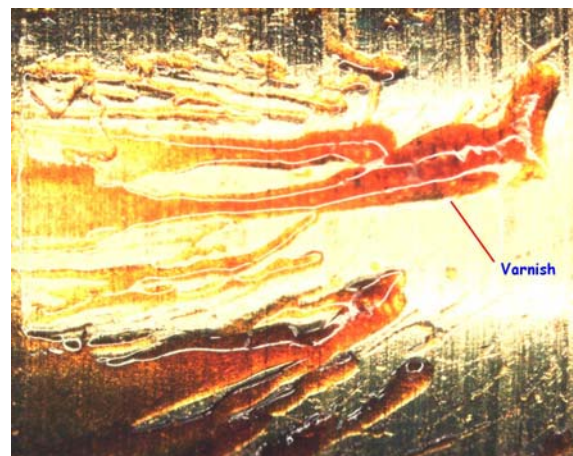
**Figure 2: Varnish on Servo Filter**

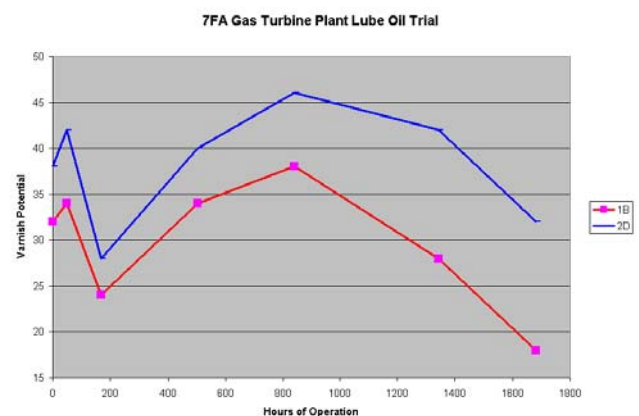
GE has performed extensive studies to validate the use of Balanced Charge Agglomeration technology. A recent test on seven 7FA+e turbines with this technology installed was run for 75 days while performing routine colorimetric sampling. The results of this test can be seen in Figure 3. Note that the results for two turbines are shown. The other five have been removed for clarity. All turbines exhibited similar results.

**Figure 3:** Balanced Charge Agglomeration Validation test

It should be noted that an initial downward trend is realized during the clean up phase followed by and upward trend as varnish that had been plated out on the system surfaces becomes reabsorbed into the oil. Over time, this varnish bloom will drop back down to desirable levels as the reclamation unit remains in service, leaving the oil system's surfaces and turbine oil clean.
