Reducing Wear Particle Generation

Ken Nicholas, Schroeder Industries; Richard Winslow, Pacificorp - Naughton Plant; Ted Naman, ConocoPhillips

A coal-fired power plant operating in the western United States was experiencing short gearbox life in its coal pulverizing operation. The AGMA 6EP (ISO 320) gear oil recommended by the original equipment manufacturer (OEM) failed to provide adequate lubrication and protection based on oil analysis results and gearbox inspection after one year of operation. This was confirmed by excessive wear metals and lower viscosity in the used oil reports. Further analysis of the used extreme pressure (EP) gear oil indicated excessive buildup of particulate contaminants in the lubricant and depletion of the EP additive package.

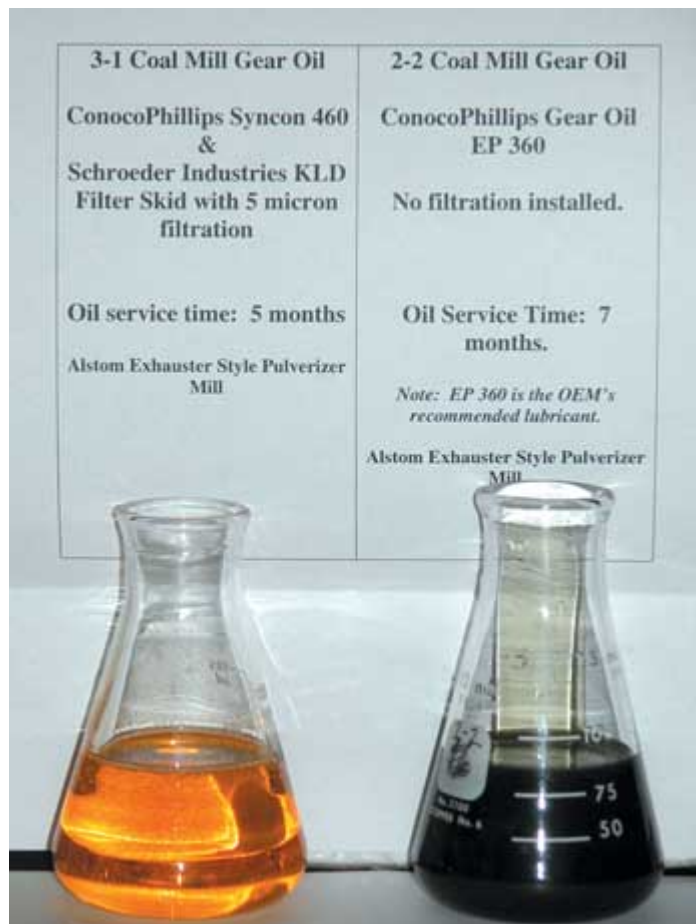
Figure 1. Comparison of Two Gear Oils

PARTICLE COUNT (Cumulative Counts / mL)							ISO CODE 4um(c)/6um(c)/14um(c)		
File #	Date	>4 um	>6 um	>14 um	>21 um	>38 um	>70 um	Sample	Target
8126	24-Nov-04	16469.00	3551.00	14.20	3.40	1.00	0.00	21/19/11	N/A
8120	14-Jan-05	4812.20	612.20	61.40	19.60	2.20	0.60	19/16/13	N/A
									N/A
									N/A

WATER CONTENT				VISCOSITY @40°C			TAN			
File #	Date	Sample		Upper Limit		Lower Limit	Sample	Upper Limit	Sample	Upper Limit
		ppm	%	ppm	%	cSt	cSt	cSt	mg/g KOH	mg/g KOH
8126	24-Nov-04	81.5	0.00815	500	0.05	391.00	469.67	529.00	0.18	1.18
8120	14-Jan-05	98.5	0.00985	500	0.05	391.00	459.59	529.00	0.19	1.18
			0.00000	500	0.05	391.00		529.00		1.18
			0.00000	500	0.05	391.00		529.00		1.18

SPECTROGRAPHIC ANALYSIS (PPM)																			
File #	Date	ADDITIVES						WEAR METALS									CONTAMINANTS		
		Mg	Ca	Ba	Zn	Mo	P	Ti	Cr	Fe	Ni	Cu	Ag	Al	Pb	Sn	Na	B	Si
8126	24-Nov-04	0.2	1.2	0.3	0.7	0.7	1735	0.3	0.1	3.6	0.1	0.5	0	0	0.4	0.6	1.2	0.3	0.8
8120	14-Jan-05	0.1	0.4	0	0.4	0.7	1635	0	0.1	0	0.1	0.2	0	0	0.2	0	0.2	0.8	0.8

PATCH TEST			
File #	Date	Sample Volume	Magnification
8120	14-Jan-05	50 millilitres	100x
Sample Contains: Wear debris, other unidentifiable black and brown particles, fiber. Please see photo at right.			
Report Date: 03-Feb-05		Analyst Lia Mirth

Figure 1. Test Report

The OEM recommended an AGMA 6EP (ISO 320) gear oil for the pulverizer gearbox. Evaluation of the wear patterns on the gear teeth indicated the EP additive package in this gear oil was too active on the bronze bull gear and was causing premature wear in conjunction with the contaminants in the gearbox. Analysis of used gear oil samples confirmed that the EP additive package was being depleted. Depletion of this package was determined to be from continuous sliding of the bronze steel gears and exposure to high temperatures, which was confirmed with IR thermographic imagery. High dirt and particulate loading was confirmed by the ISO cleanliness code. It was now obvious that the OEM recommended EP gear oil did not provide adequate protection for the gears.

Based on these findings, and after consulting with the lubricant supplier, it was determined that AGMA 7 (ISO 460) synthetic gear oil would best protect the gearbox in this application. The higher viscosity grade and improved lubricity of this synthetic gear oil, coupled with R&O additive chemistry, provided a higher oil film strength than the OEM's recommendations, and would extend the life of the gearbox, taking into account the temperature requirements and gearbox longevity.

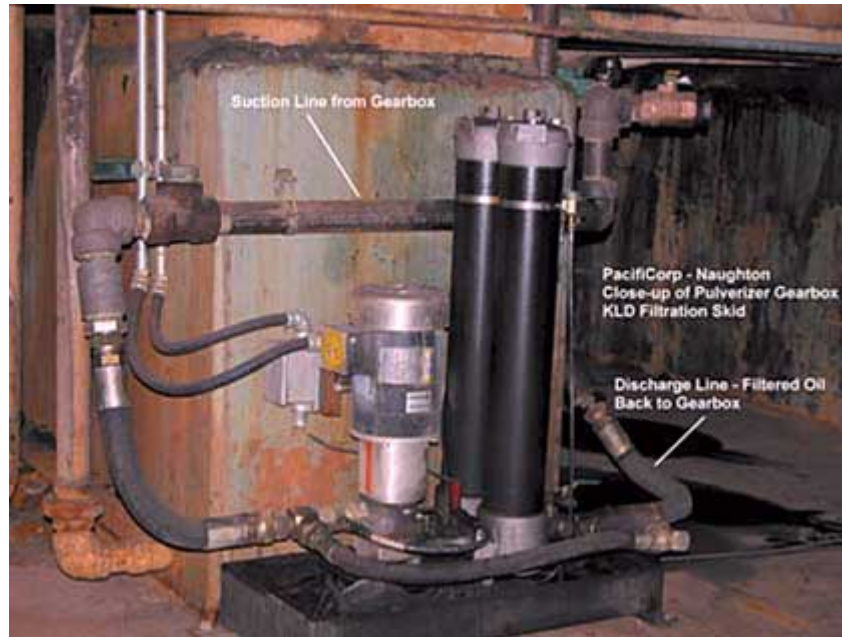
Figure 2. Kedney Loop Filtration System

An off-line kidney loop filtration package using a high- efficiency, high dirt-holding capacity, synthetic filter media was procured and installed. The package uses two filter housings mounted in series, with a common-sized element in both housings.

The filter elements initially recommended for the trial installation were rated at beta 25= 200 in the first stage and beta10= 200 in the second stage. Oil flow was delivered by a vane pump rated at 10 GPM for a 460 cSt (2,500 SUS) gear oil. Temperature ranges of the system fluid varied from as low as 65°F (18°C) when idle and up to 130°F (54°C) during normal operation. The filtration package is installed with the suction line coming into the filter bank directly from the bottom of the reservoir; the outlet, or filtered discharge line, is piped into the top of the reservoir.

The filter element condition is monitored by differential pressure gauges installed on each filter housing with a target of 25 to 28 psig as an indicator of element loading. The elements were changed out prior to allowing the internal bypass valve to open. Other features of the filtration package include upstream and downstream sampling valves to allow gear oil samples to be taken without having to shut down the system.

The pulverizer gearbox was overhauled and all major rotating components replaced, with the exception of the steel/worm gears. The gearbox was wiped clean with lint-free rags as part of the overhaul process. The steel worm and bronze bull gears were precision aligned and blue checked. The reservoir was flushed with an ISO 460 mineral oil and filled with the synthetic ISO 460 gear oil. A baseline gear oil sample was drawn from the reservoir and analyzed for particle count per ISO 4406-1999. The ISO cleanliness code result was 23/21/18. The pulverizer gearbox was put into service along with the filtration system. Following three hours of run time, the particle count was reduced to 21/19/11.

After 48 hours of run time the plant installed a set of beta 5= 200 filter elements in each housing to reduce system contamination and achieve the target ISO cleanliness code 18/15/11. The pulverizer gearbox and filtration system continued to run for another two weeks

with the element condition monitored using differential pressure gauges. As a result of using the Beta 5= 200 filter during these two weeks, the target ISO cleanliness code 18/15/11 was reached.

Filter element service life was also monitored during the trial installation. Results indicated the high dirt capacity media exceeded expectations, given the initial cleanup of the system, plus the service life during ongoing usage has been above the norm. Average service life to date, using the beta 5= 200 media, is one year.
